**SPENARD ROAD: HILLCREST DRIVE TO MINNESOTA DRIVE**  
**Channelization and Pedestrian Facilities Improvement**  
**PROJECT No. HRO-0001(172)/53986**

**TRAFFIC AND SAFETY ANALYSIS**  
**FINAL**

## TRAFFIC AND SAFETY ANALYSIS

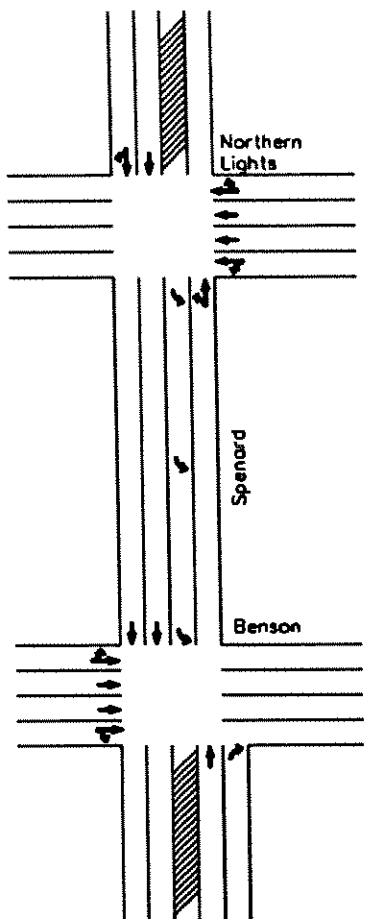
BNL1

INTERSECTION CONFIGURATIONS  
 FIGURE 5.1

Five alternative intersection configurations were identified for the Benson/Northern Lights intersections, one alternative configuration was identified for the Fireweed intersection, and one alternative was identified for the 36<sup>th</sup> Avenue intersection. Figure 5.1 shows the alternative intersection configurations. The one Benson/Northern Lights alternative configuration not illustrated (BLN5) consists of the Benson signal operating in a split phase mode under the existing lane configuration. The following tables show the capacity analysis results. Estimated queue lengths for each alternative can be found in the LOS reports in Appendix D.
